Manhole Inspection Summary

Manhole # S05YY_018MH

Insp Date: **12/23/08 3:11 PM**

Location Address: **3901 LIBERTY HEIGHTS AVE**

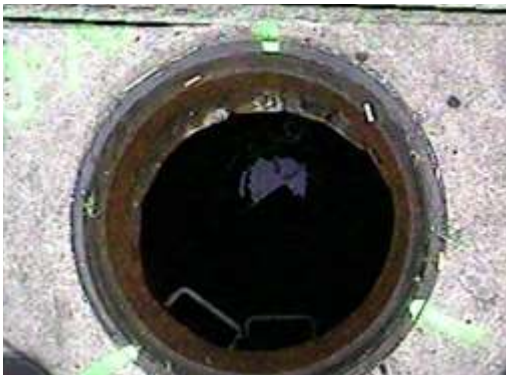
Top View

Offset: **2** (in.)

OFFSET FRAME AND CHANNEL

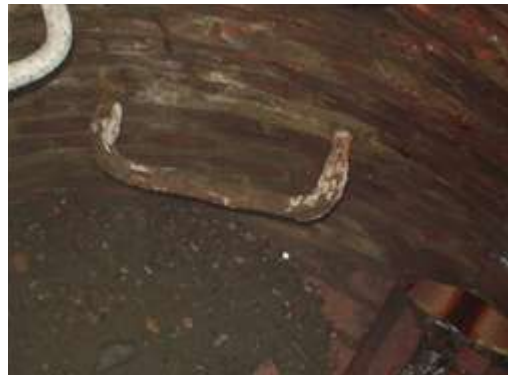
Defect 1

Count: **3** Missing: **0** ☒ **Corroded**

CORRODED STEPS

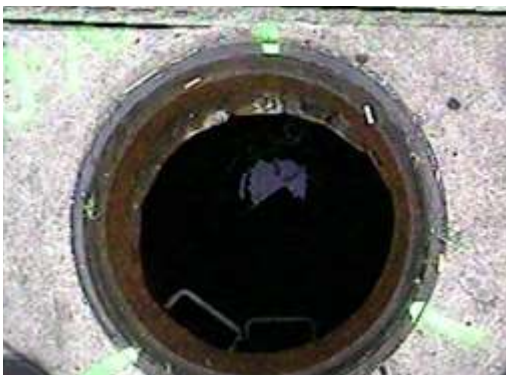
Defect 2

Condition: ☐ Sound ☐ Cracked ☐ Root Intrusion ☒ **Loose Brick** ☒ **Deteriorated**

LOOSE BRICKS AND DETERIORATED
FRAME ADJUSTMENT
